# ANNUAL REPORT FOR 2015

**Plum Branch Site #33 Mitigation Site**  
**Yancey County**  
**TIP No. R-2519A**  
**COE Action ID: SAW-2007-2197-357/300**  
**DWR #: 2007-1134V.4**

Prepared By:  
Natural Environment Section & Roadside Environmental Unit  
North Carolina Department of Transportation  
December 2015

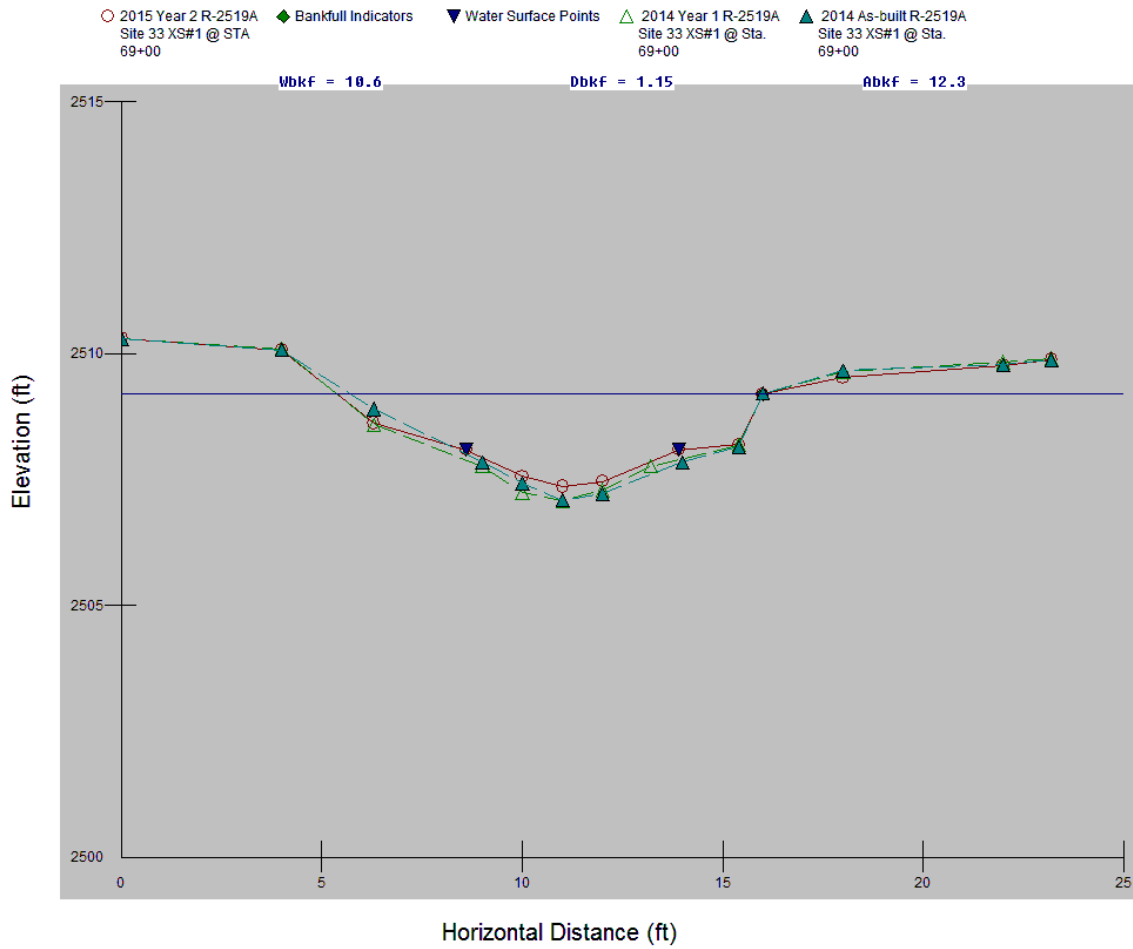
# R-2519A Site 33 XS#1 @ STA 69+00

Site #33: Cross-Section #1 (Pool) Abbreviated Morphological Summary					
	2014	2015	2016	2017	2018
Bankfull Cross Sectional Area (ft <sup>2</sup> )	13.93	12.25			
Maximum Bankfull Depth (ft.)	2.13	1.84			
Bankfull Mean Depth (ft.)	1.31	1.15			
Bankfull Width (ft.)	10.64	10.62

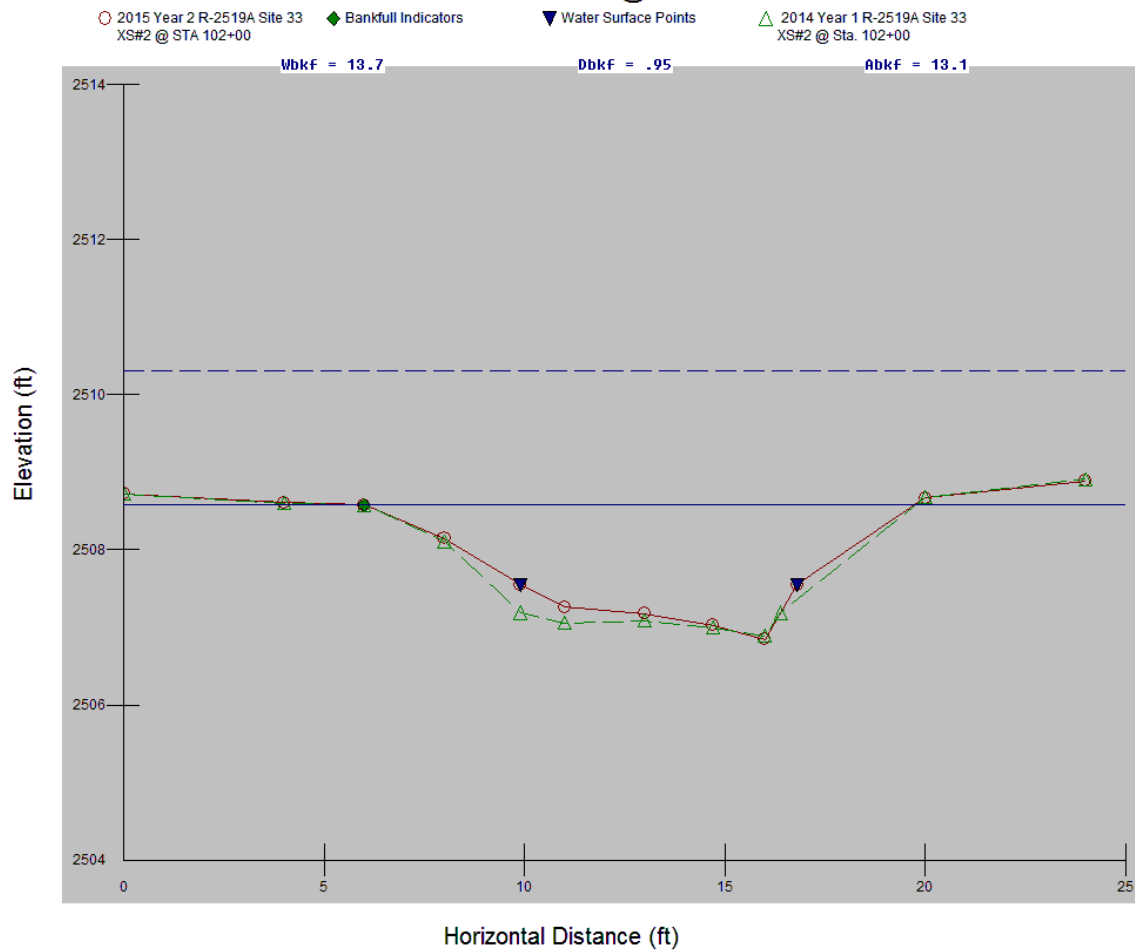
# R-2519A Site 33 XS#2 @ STA 102+00

Site #33: Cross-Section #2 (Riffle) Abbreviated Morphological Summary					
	2014	2015	2016	2017	2018
Bankfull Cross Sectional Area (ft <sup>2</sup> )	14.53	13.09			
Maximum Bankfull Depth (ft.)	1.69	1.73			
Width of the Floodprone Area (ft.)	24	24			
Bankfull Mean Depth (ft.)	1.06	0.95			
Width/Depth Ratio	12.98	14.46			
Entrenchment Ratio	1.74	1.75			
Bankfull Width (ft.)	13.76	13.74

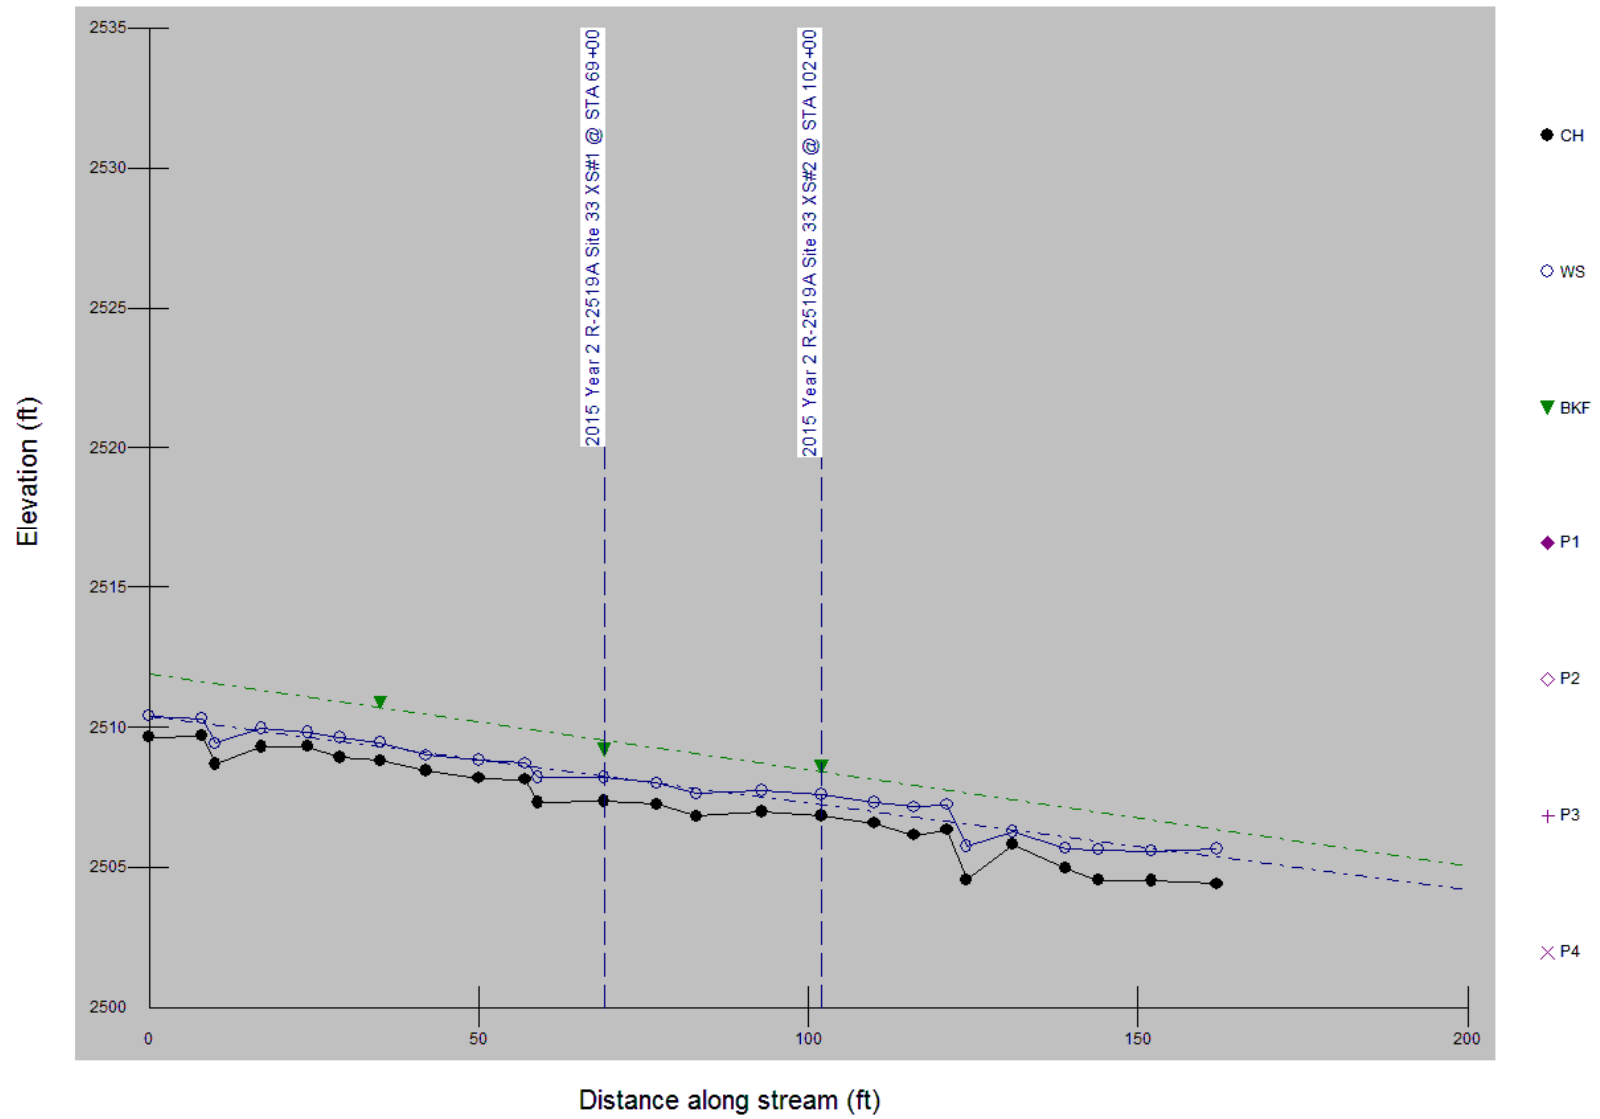
2015 Year 2 R-2519A Site 33 Profile

Based on comparisons of the As-Built to the monitoring data, all of the cross sections appear stable with little or no active bank erosion. Graphs of the cross sections are presented in Appendix A. Future survey data will vary depending on actual location of rod placement and alignment; however, this information should remain similar in appearance. The longitudinal profile showed that the channel was stable for the 2015 monitoring evaluation. Pebble counts were not required per the permit conditions and therefore were not completed. Two bankfull events were documented visually by a noted wrack line at Site #33 during the 2014 and 2015 monitoring years.

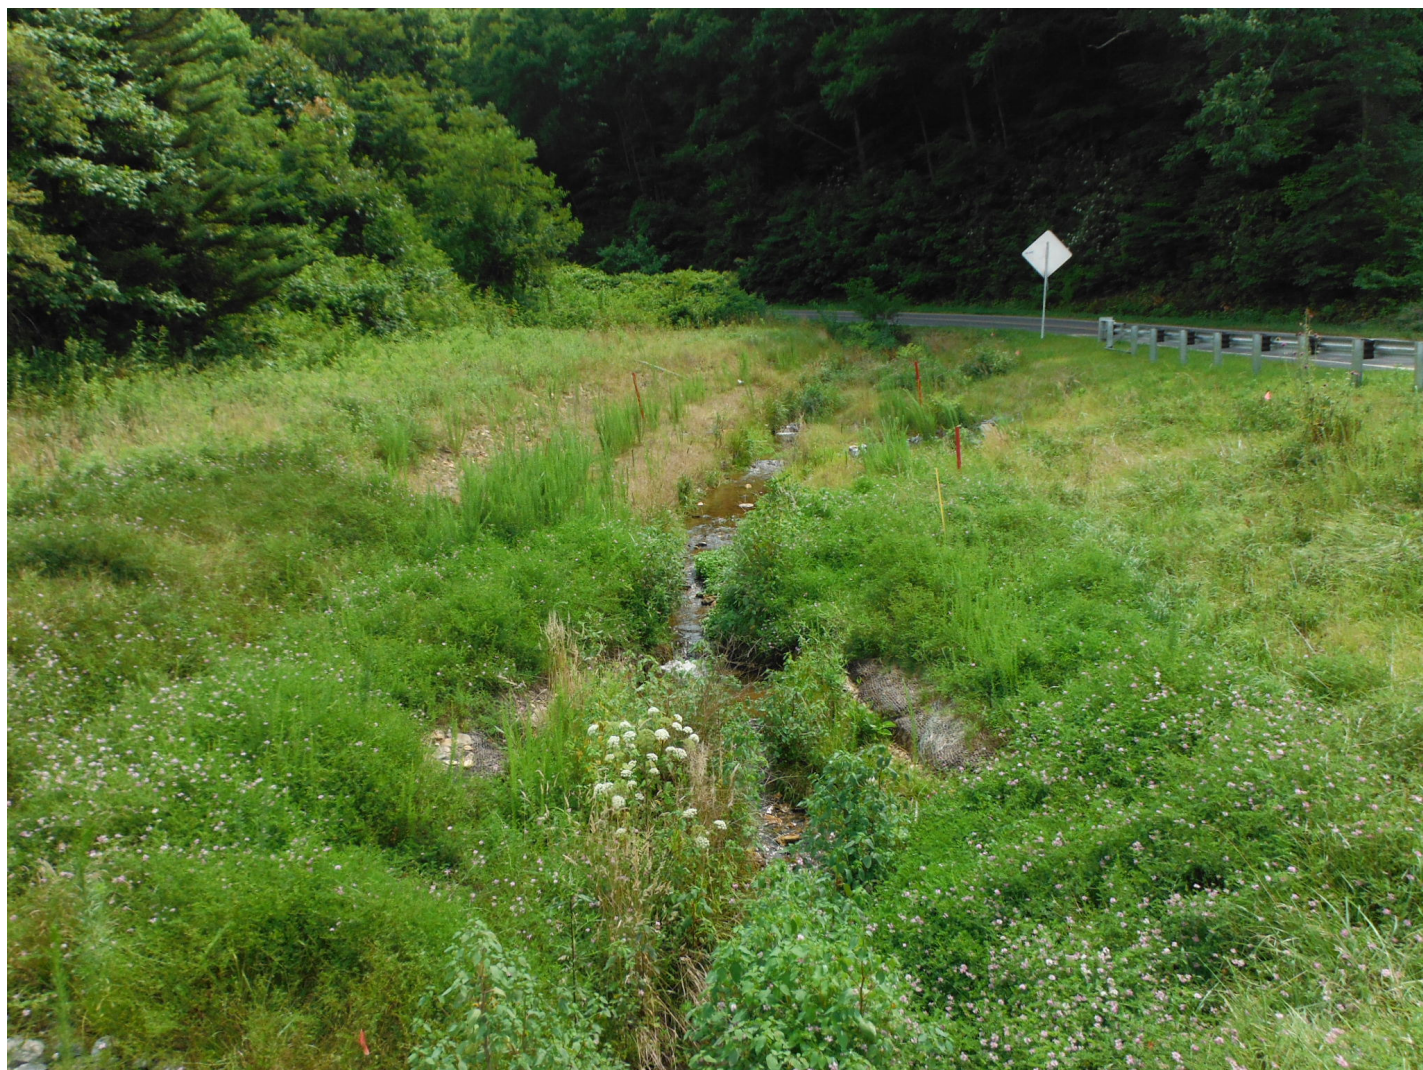
Vegetation Overview Photo

**Streambank & Buffer Vegetation:** The Streambank reforestation was completed in March 2015. The Year 1 vegetation monitoring evaluation noted: Type I: Silky Dogwood and Silky Willow and Type II: Sycamore, Green Ash, Tulip Poplar, and White Oak were surviving at the time of the monitoring evaluation. Small patches of Japanese Knotweed were sprayed in July 2015.
